Flight 60 SW Version Release
5.31

Flight 60 Turbine SW Version Release

Version 5.31

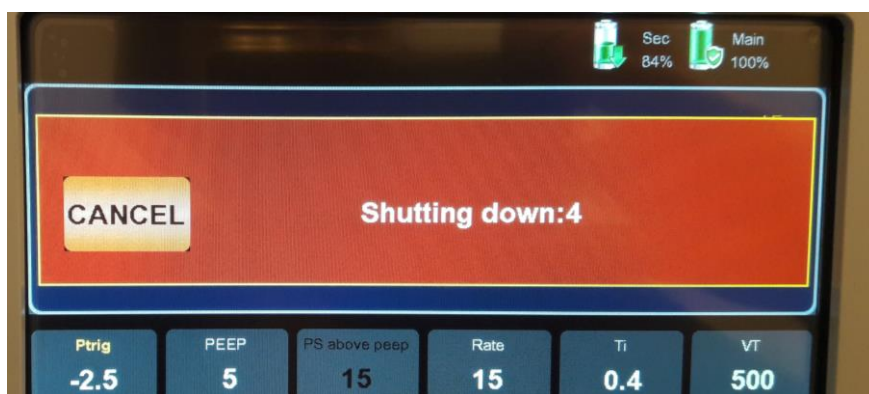
1. Shutting down in one press button

During standby mode, shut down is available in one press button without additional confirmation.

Once the shutdown is pressed, a warning pop-up panel “Shutting down” is displayed with countdown of 5 seconds

Pressing on the “CANCEL” button, cancels the shutting down process.
